## Case History

<b>Client</b>	Rio Tinto
<b>Location</b>	Clermont, Queensland
<b>Colour</b>	Light Grey (N35)/Various
<b>Area</b>	3000m <sup>2</sup>
<b>Installer</b>	The Epoxy Coating Specialists

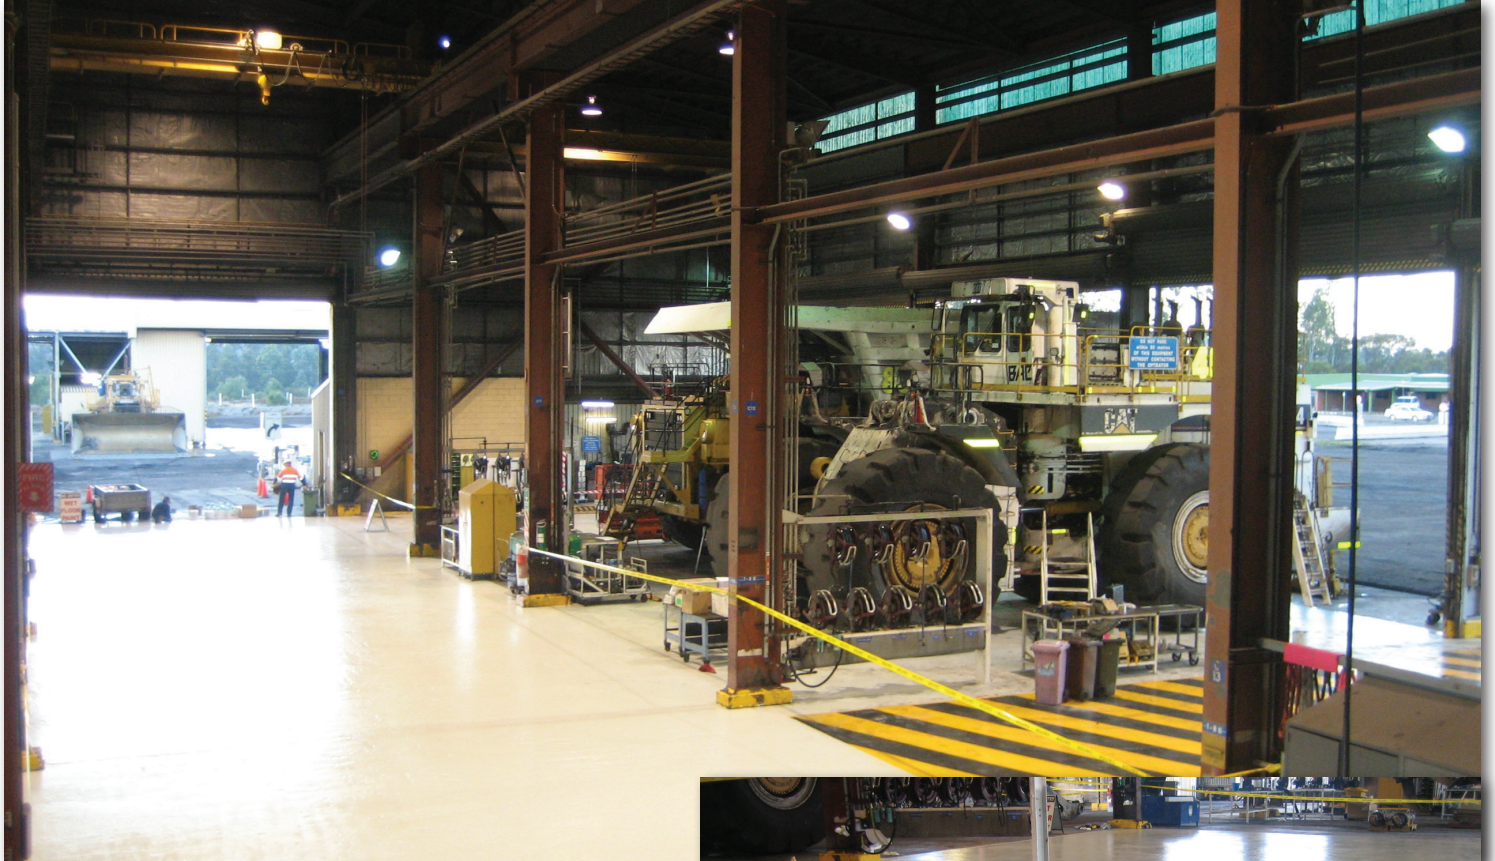
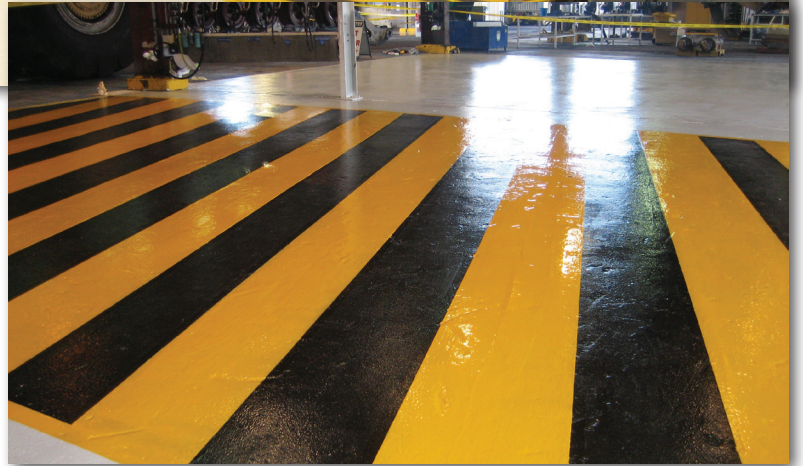
- The existing epoxy coating had been worn down and needed to be replaced. In fact, the old floor was so badly damaged that fitters were unable to wheel tool trolleys across the surface.
- Surface preparation consisted of diamond grinding and high-pressure hot water rotary cleaning with a heavy-duty degreasing solution. Damaged areas were filled using an epoxy mortar consisting of Jaxxon 1525, aluminium oxide and quartz filler.
- The Kevlar®-reinforced Jaxxon 1525 was then applied and broadcast with aluminium oxide for a non-slip texture, followed by a topcoat of Jaxxon 1525 to encapsulate the particles and fully seal the floor.
