RESIN GRIP™

Non-slip Flooring System

Case History

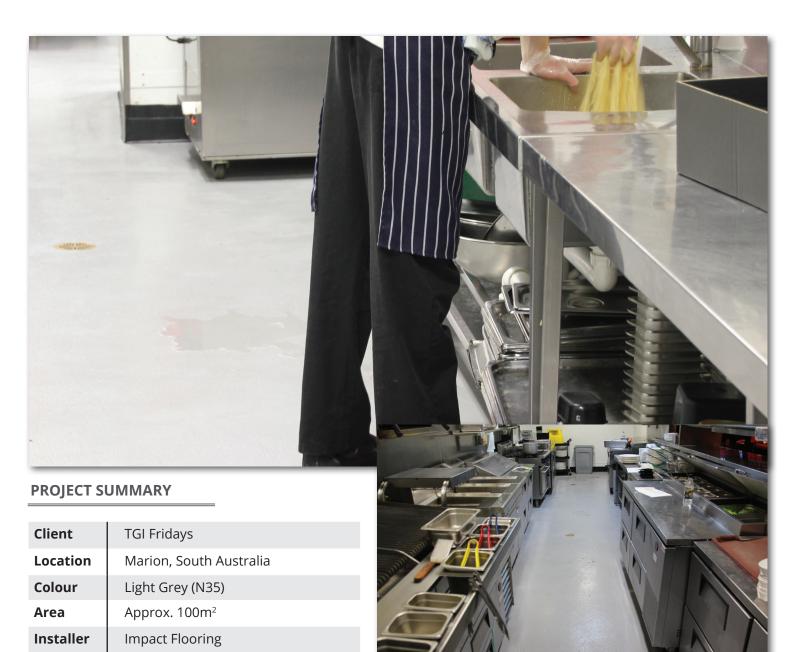
- The sheet vinyl used in the commercial kitchen was deteriorating after two years of service. Major symptoms included cracking (at seams, transitions and drains), splitting and peeling.
- The hot, wet conditions in these areas can lead to bacterial growth within the cracks/gaps and underneath the failed floor. A new floor had to be installed urgently, with a seamless, water-resistant epoxy well suited.
- After the vinyl was removed, it was discovered some sections of leveller underneath had been damaged by moisture. An epoxy leveller was used to re-level the surface in preparation for coating.
- A non-slip finish with an R12 rating was applied as per commercial kitchen requirements at the time.
