## Case History

<b>Client</b>	Xstrata Zinc
<b>Location</b>	Mt. Isa, Queensland
<b>Colour</b>	Light Grey (N35)
<b>Area</b>	1200m <sup>2</sup>
<b>Installer</b>	The Epoxy Coating Specialists

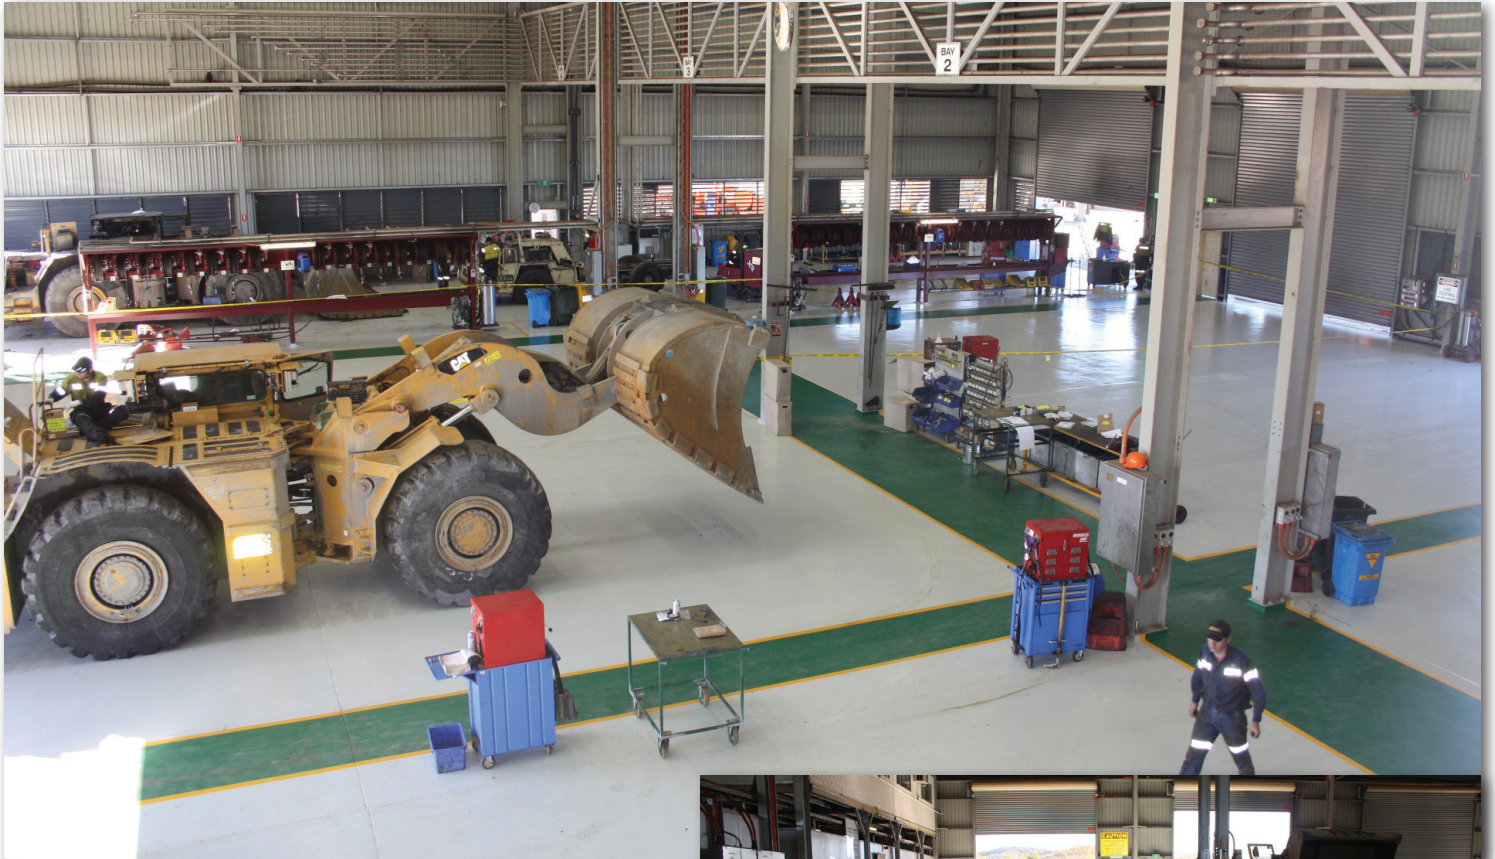
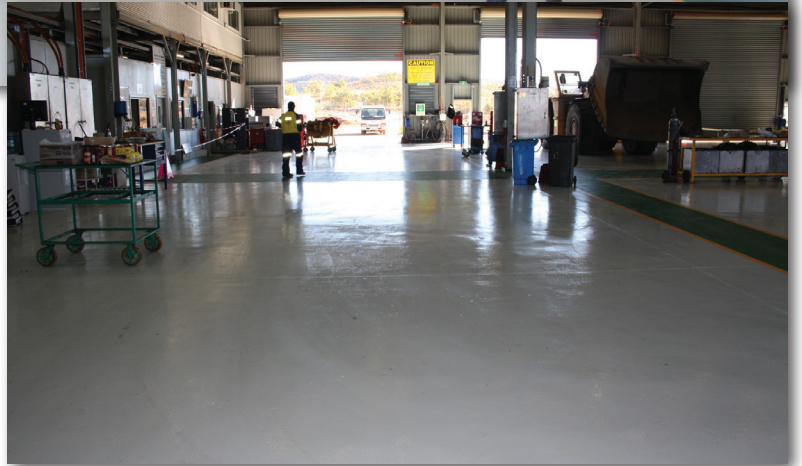
- The existing epoxy coating had been worn down and needed to be replaced.
- To prepare the heavily contaminated 1200m<sup>2</sup> workshop area, a high-pressure hot water rotary clean was administered and followed up with a diamond grind.
- Selection of the Kevlar®-reinforced Jaxxon 1525 was made due to its excellent wear and impact resistance. Two coats of were then applied by roller.
