## RESIN GUARD™

Protective Flooring System

## **Case History**

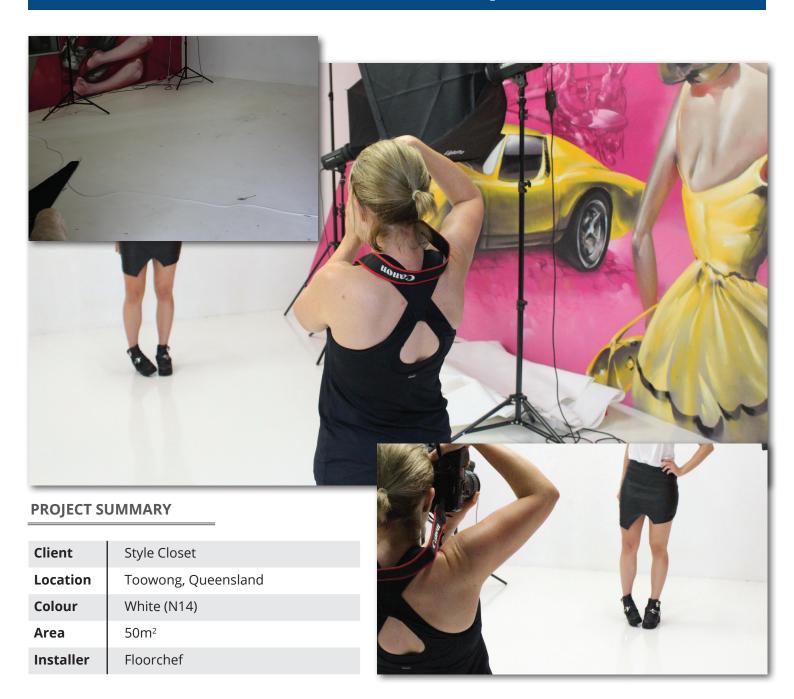
- White floor finish chosen to provide clean, professional platform for photo shoots. Previous coating was deteriorating and starting to look permanently dirty.
- Non-slip topcoat option used to reduce gloss levels of floor, which helps limit glare during shoots.
- Coving installed along sections of the wall to make it easier to clean and avoid dirt build-up (which can become visible in photos).
- Studio situated underneath family home, with installation carried out while occupants present. A product free of pungent odours and dangerous solvents was a priority.
